**DEPARTMENT OF TRANSPORTATION****DIVISION OF ENGINEERING SERVICES**

Contract #: 04-0120F4Cty: SF/ALA Rte: 80 PM: 13.2/13.9File #: 69.28**WELDING INSPECTION REPORT****Resident Engineer:**Pursell, Gary**Address:** 333 Burma Road**City:** Oakland, CA 94607**Report No:** WIR-002670**Date Inspected:** 20-May-2008**Project Name:** SAS Superstructure**OSM Arrival Time:** 1400**Prime Contractor:** American Bridge/Fluor Enterprises, a JV**OSM Departure Time:** 2300**Contractor:** Zhenhua Port Machinery Company, Ltd (ZPMC), Changxing Island **Location:** Shanghai, China**CWI Name:** Ye Yong Jun**CWI Present:** Yes No**Inspected CWI report:** Yes No N/A**Rod Oven in Use:** Yes No N/A**Electrode to specification:** Yes No N/A**Weld Procedures Followed:** Yes No N/A**Qualified Welders:** Yes No N/A**Verified Joint Fit-up:** Yes No N/A**Approved Drawings:** Yes No N/A**Approved WPS:** Yes No N/A**Delayed / Cancelled:** Yes No N/A**Bridge No:** 34-0006**Component:** Caltrans OBG, Tower**Summary of Items Observed:**

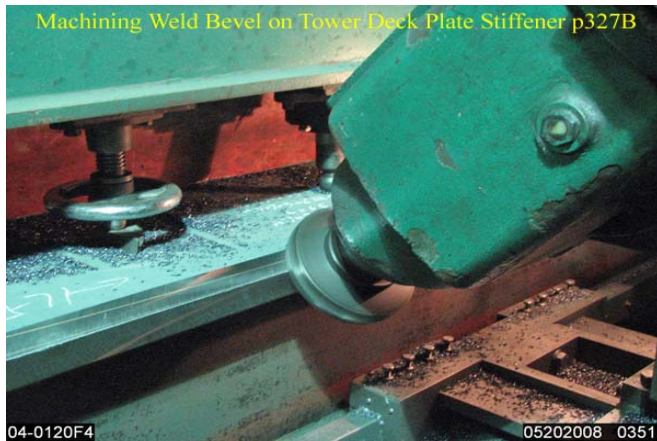
The Caltrans QA Inspector randomly observed the machining of the weld bevel on stiffener (Member I. D. p327B) for Tower deck plate. See picture below.

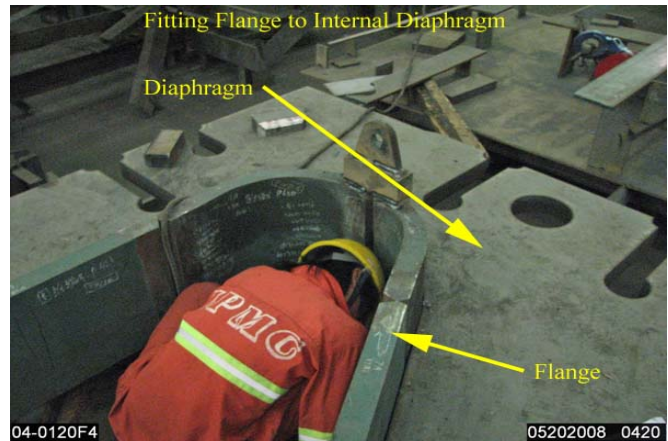
The Caltrans QA Inspector also randomly observed the fitting and tacking of flanges to internal diaphragms at three work stations. Tacking was being performed in the vertical groove (3G) welding position using the shielded metal arc welding (SMAW) process. See picture below.
